# Building Inspection Report

**111 Anywhere, Tupelo, MS**

4/2/2010

**Assured Home Inspection, Inc.**

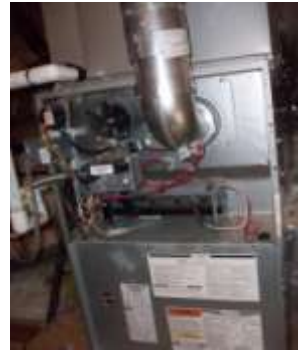
- **Improve:** The dirty air filter should be replaced.
